Biological Deterioration and their Chemical Conservation with Reference to Chandraditya Temple, Barsoor

Sanjay Prasad Gupta^{1*} and Kavita Sharma²

¹Archaeological Survey of India, Raipur Circle, Govind Sarang Comm. Complex, 1st flore, New Rajendra Nager, Raipur (Chhattisgarh), 492006, India

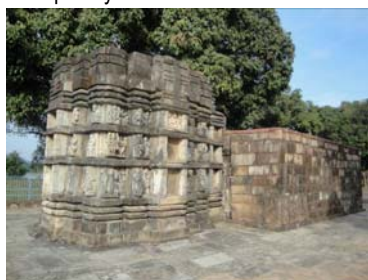
Fig : 1 (a) Chandraditya Temple (Lateral view) Before Scientific Conservation

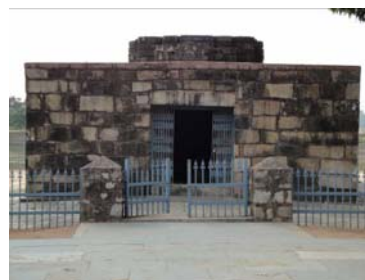
Fig : 2 (a) Chandraditya Temple (Front view) Before Scientific Conservation

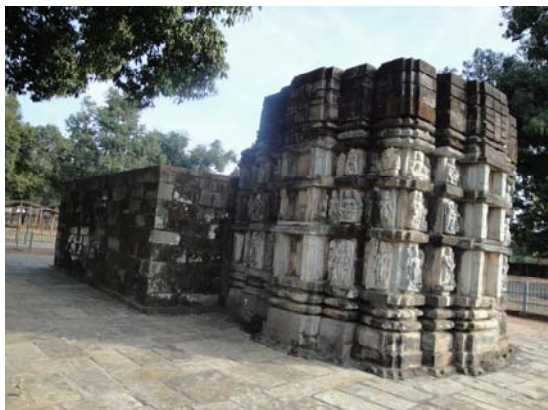
Fig : 3 (a) Chandraditya Temple (Ventral view), Before Scientific Conservation

The stone surface of the Chandraditya temples have become blackish in appearance due to deposition of dust, dirt and dried vegetation & micro vegetation growth. The depositions area seems to be very old age depicted by the formation of secondary lichens of dull green pale white colour which are present all over the stone surface. Due to these

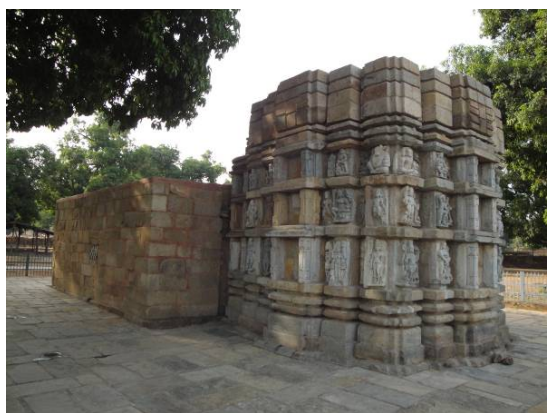
Fig : 3 (b) Chandraditya Temple (Ventral view) After Scientific Conservation

The steps taken by Archaeological Survey of India for the removal of dust and dirt accretion upkeep of stones in neutral pH and preservation and stone strengthening Strategies by soft brushing. The moss, fungi and lichen were removed by applying 2-3% solution of ammonia in water and scrubbing with nylon brush. Black patches appeared after removal of thick layer of moss, fungi and lichens which were washed out with the help of dilute solution of oxalic acid in water. A dilute solution of a non ionic detergent with liquid ammonia was applied on treated surface to remove dirt, dust and little amount of acid and ammonia if remained on the surface during

the chemical treatment. Lime wash, red ocher and iron oxide accretion were removed using dilute (10-15%) aqueous acetic acid and oxalic acid solution as per the suitability and afterwards neutralized using aqueous ammonium hydroxide solution. To Arrest further micro vegetation growth 2% aq. Solution of sodium pentachlorophenate was applied on clean dried surface (W. H. Dukes, Conservation of Stone, August, 23, 1972). The brittleness and powdering of stones were arrested by the application (brushing and impregnation till saturation) of ethyl silicate based coating material which forms glass like silica gel binder (SiO_2 aq.) with release of ethanol (evaporates) as by products. Here, noteworthy point is that the intake of stone strengthener materials was comparatively more in the case of damaged and pulverized stones. This can be attributed to the availability of more pores for penetration. The coating of stone strengthener applied on the deteriorated and flaky stone surface by simple brushing and impregnation till saturation.

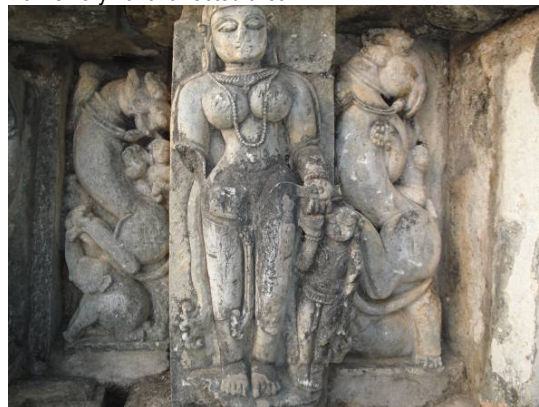
Fig : 4 (a) Deteriorated Statue, Before Conservation

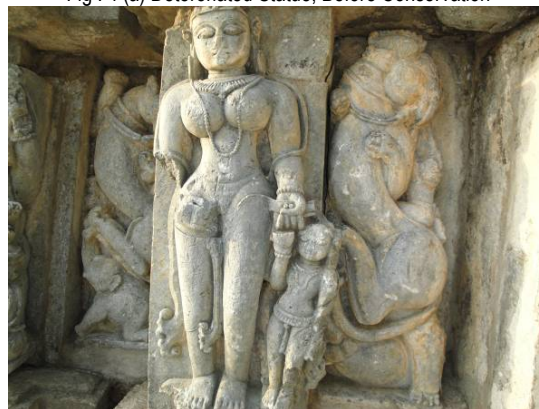
Fig : 4 (b) Deteriorated Statue, After Conservation

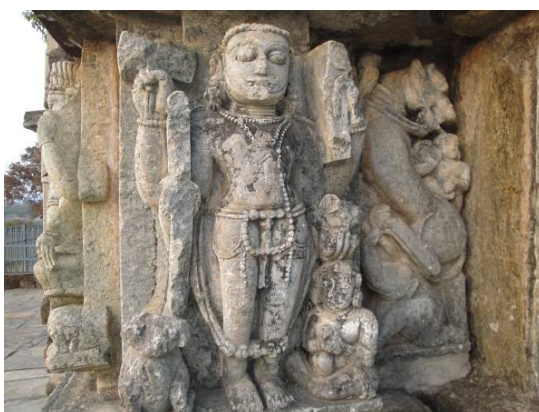
Fig : 5 (a) Deteriorated Statue, Before Conservation Conservation problem

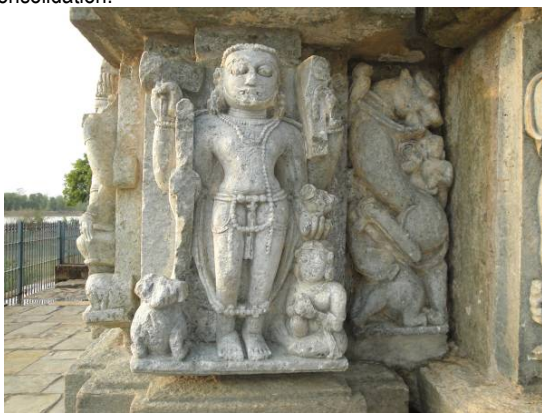
Fig : 5 (b)Deteriorated Statue, After Conservation
